Powder Coating Study for starter motor

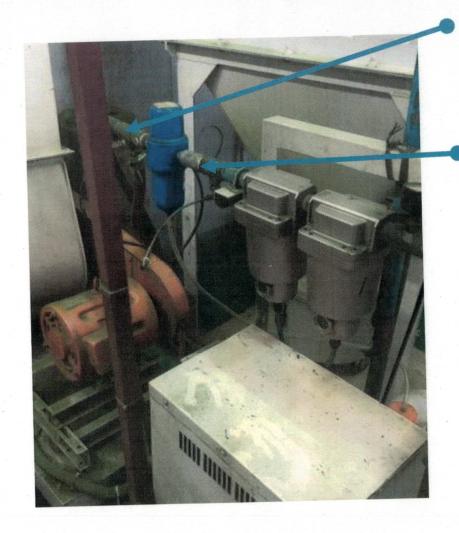
Air Point where sample is taken After MAEDA Filter

Air Point where sample is taken Before MAEDA Filter and After LTVS existing filter

Painting failure:
Before 40%
After 3%

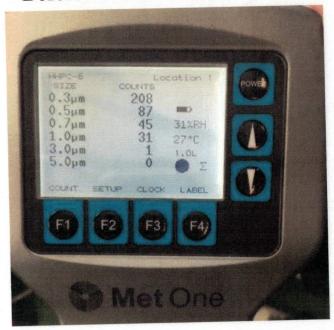
Before MAEDA Filter the Particles size from 0.3micron to 3.0micron was available in No: of counts as per enclosed picture

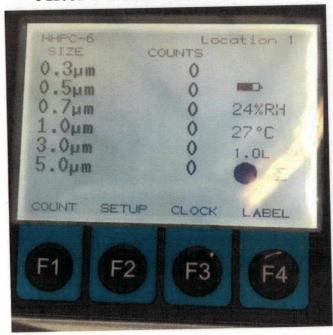
After MAEDA Filter the Particles size from 0.3micron to 3.0micron was '0' in No: of counts as per enclosed picture
